# Dredging as Remediation for White Phosphorus Contamination at Eagle River Flats, Alaska

Michael R. Walsh and Charles M. Collins

August 1998

CRREL Report 98-5

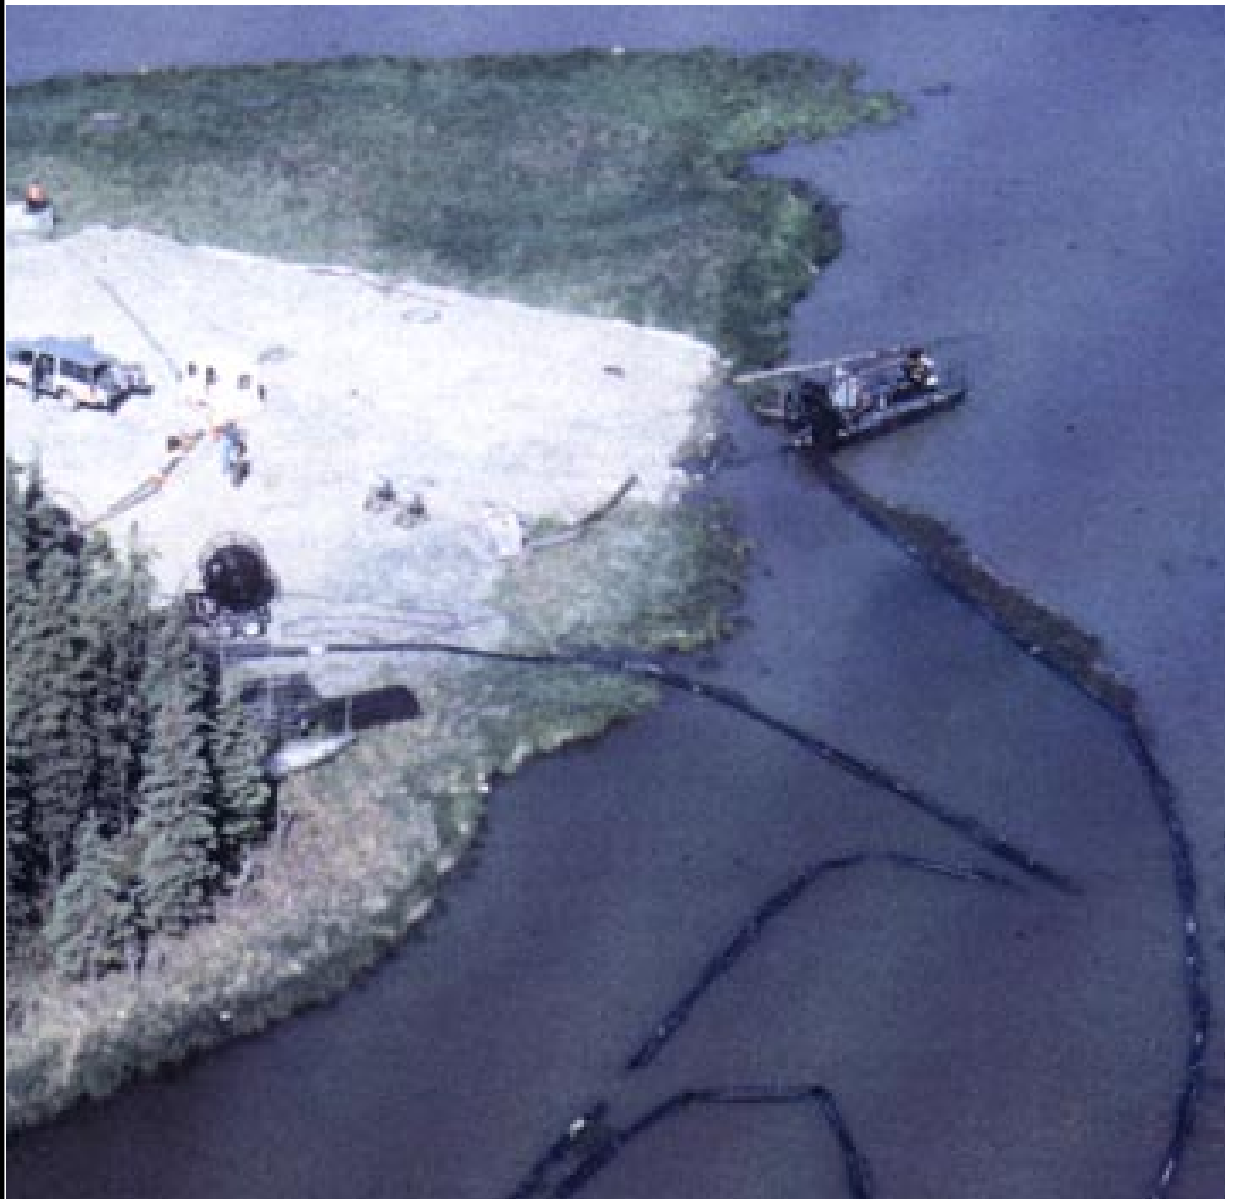
*Cover: Start of dredging operations off Clunie Point, Eagle River Flats, Alaska, in June 1995. The operator cab is in the center of the gravel pad; the dredge is to the right.*

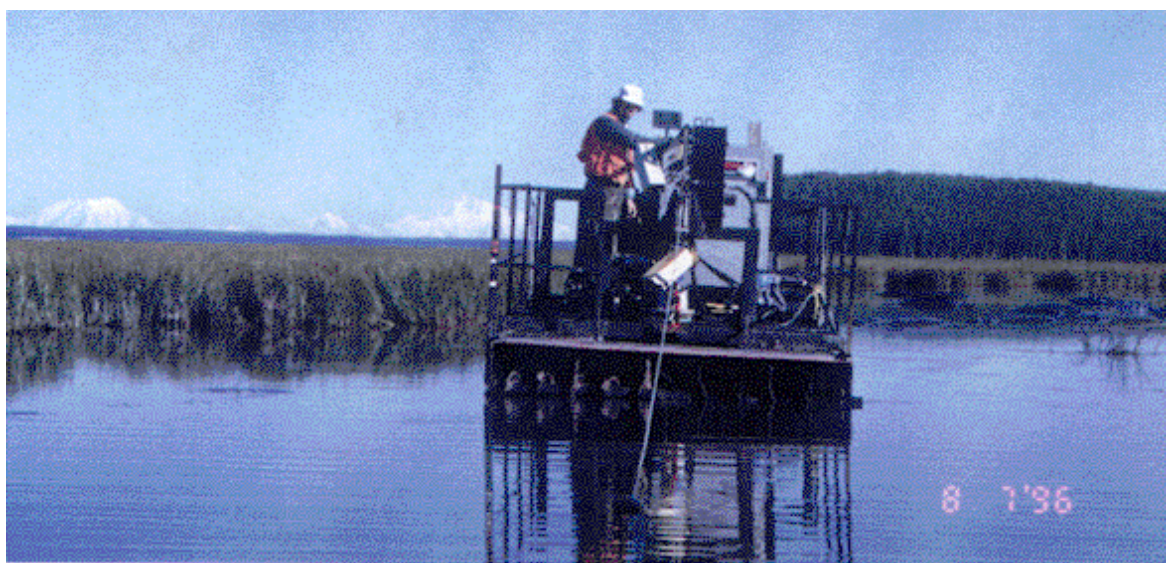
Figure 2. Dredge.

An augerhead-type hydraulic dredge (Fig. 2) was leased locally and modified for the dredging operations (Walsh et al. 1996). An augerhead dredge was specified due to the nature of the contaminant. White phosphorus is easily resuspended in water and settles slower than the sediments found at the Flats due to its lower specific gravity. The enclosed augerhead contains the sediment during the dredging process, thereby reducing the recontamination of the dredged area. The dredge traverse system was anchored using 1-m<sup>3</sup> (1800-kg) concrete deadmen placed by helicopter, supplemented by screw anchors placed in areas cleared of ordnance (Fig. 3). The use of spuds and lateral cables was considered but rejected on the basis of the danger involved in setting the spuds in the sediment of the Flats as well as the difficulties involved in excluding ordnance from the basket dredge head. It is also more difficult to operate this type of system remotely.

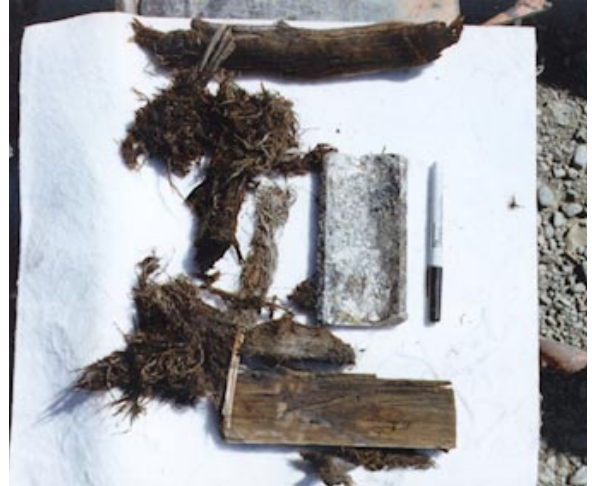
*Figure 6. Slurry pump eye clogging.*

Although the dredge system is designed to process vegetation, the presence of boardwalk and other woody debris was problematic for the pump. Chunks of wood became lodged in the eye of the pump during dredging operations, and the blockage quickly accumulated other debris in a process called “beaver-damming” (Fig. 6). Evidence of this phenomenon first surfaced during pumping tests, with cyclic surging, the period of which was related to impeller speed. The surging was caused by cavitation due to inlet starvation and the backflow of water into the pump. When pump blockage was suspected, the dredge was pulled from the water and the pump eye examined. It was found to be clogged with debris. The instigators in all occurrences were waterlogged sections of boardwalk approximately 70 mm × 20 mm × 150 to 200 mm long. Because the wood was of near-neutral buoyancy, it did not drop out in the expansion (boom) box located ahead of the pump. We also found that aluminum objects did not always drop out.

*a. Debris in pump eye.*

*b. Extracted debris. Note aluminum illumination round section.*

Although the boom box was effective in keeping out the heavier steel debris, it was not functioning when confronted with lighter materials. A coarse screen system was installed in the boom box, but that quickly plugged, crippling the

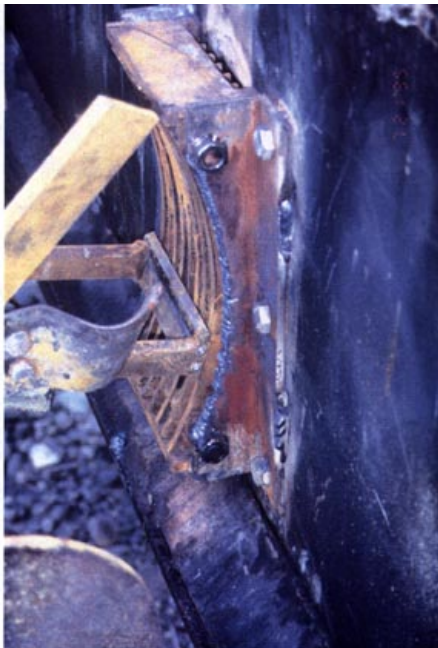
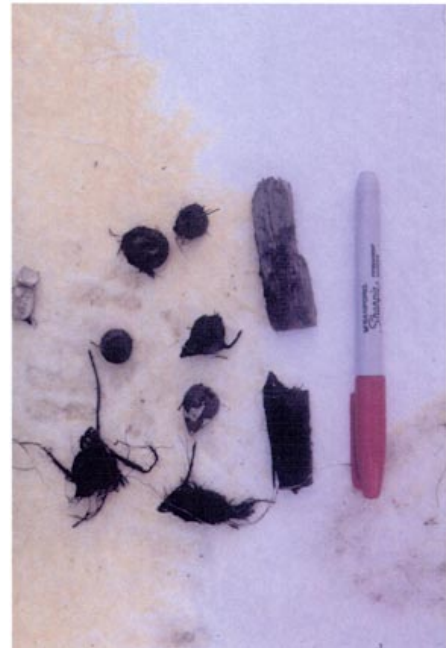
*Figure 7. Test cutter and grate system for dredge augerhead intake.*

tion by sweeping debris up the grates and cutting it at the top. A tapered transition section behind the grates smooths the flow of water from a rectangular cross-sectional opening to a 15-cm-diam. hose adapter. Stiff tines are attached to the auger flites to augment maceration of vegetation prior to ingestion.

*a. Side view of grates with cutter.*

*b. Debris extracted from gates, with pen for size comparison*

during testing. Operational usage of the system indicated that extended run-time was possible with the grates installed. However, some plugging of the grates was experienced. For the most part, the debris was confined to the upper and lower 5 cm of the grates. The material lodging in the grates consisted of small chunks of wood (boardwalk), hard vegetative nodules, and root masses. Some modification of the grates was done to reduce entrapment, but the cause of the plugging was the deflection of the grates by material slightly larger than the grate openings.

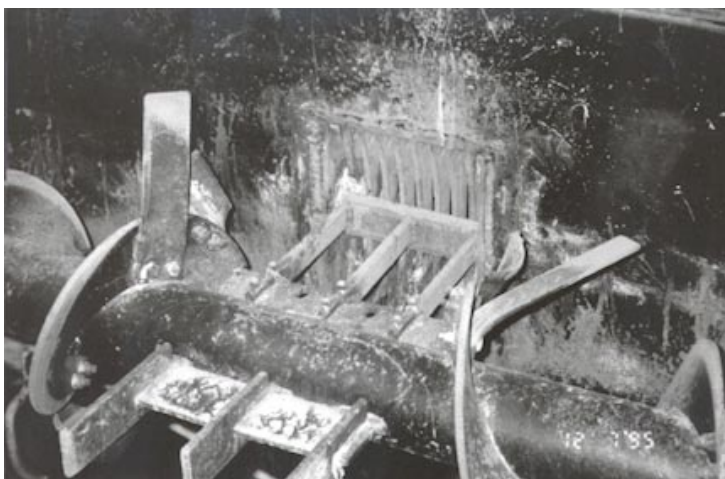
*Figure 8. Mk. II cutter/grate system.*

The stiff tines and cutter of the cutter/grate system added to the torsional resistance of the auger. A new hydraulic augerhead motor with twice the torque and half the speed of the original was installed. In the process, the hydraulic hoses were replaced, as they had been abrasively worn. During dredging operations, the protruding drive motor is forced through the undredged material to the side of the dredgehead. This causes wear on the component as well as resistance to forward motion. The drive motor needed to be located behind the shroud, and the auger driven with a chain.

*a. Cutter and grates. Note vertical stiff tine.*

*b. Top view of transition box showing manual cleanout.*
